Statistical Analysis of the Technical Condition of the Irrigation Pipeline of the Community of San José De La Silveria through the Measurement of Thicknesses by Ultrasound

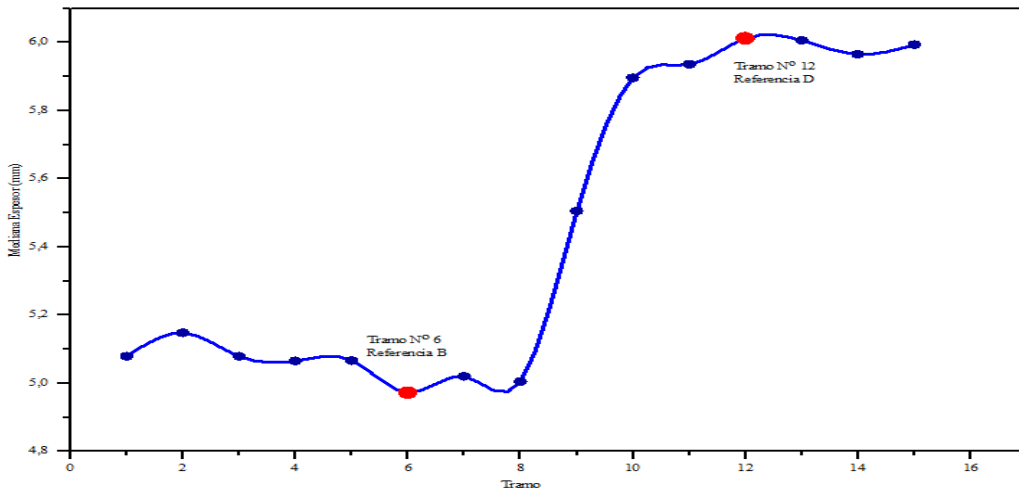
Fig. 9: Trend Curve Thicker than the Median. Fountain.

Based on the data set out in the **Error! Reference source not found.**, The medians of each section are represented in the Fig. 9 for their respective thickness analysis, where it is observed that section 12 has a greater thickness trend at reference point D, while section 6 presents a lower thickness within reference point B.

Based on the nominal thickness value of 7.11 mm, proposed by Quinchuela in 2021, an average wear of 1.66 mm is observed at reference points A, B and D, which represent a minimum wear of 25.4% due to the location of these reference points, as can be seen in Fig. 2 resulting in less fluid alteration and a lower wear rate.

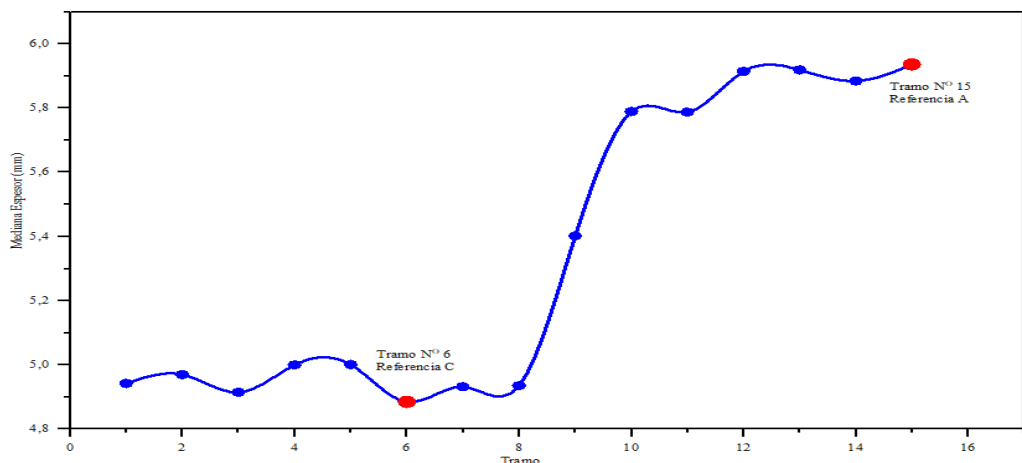
Fig. 10: Trend Curve of Lower Thickness than the Median. Fountain.

As for the analysis of the smallest thickness as a function of the mean, with the data presented in the Board 2, The Fig. 10, where it can be observed that section 15 has a greater thickness, while in section 6 there is a lower trend in terms of lower thickness. It is important to note that reference point C, within the 15 sections, is more random.

Based on the nominal thickness of 7.11 mm, an average wear of 1.76 mm is generated within the reference point C, which presents greater wear with a material loss of 74.6% progressively, due to the fact that the reference point is located at the top of the pipe, where there is a greater alteration of fluid and a higher wear velocity. This is due to the particles contained in the irrigation water.

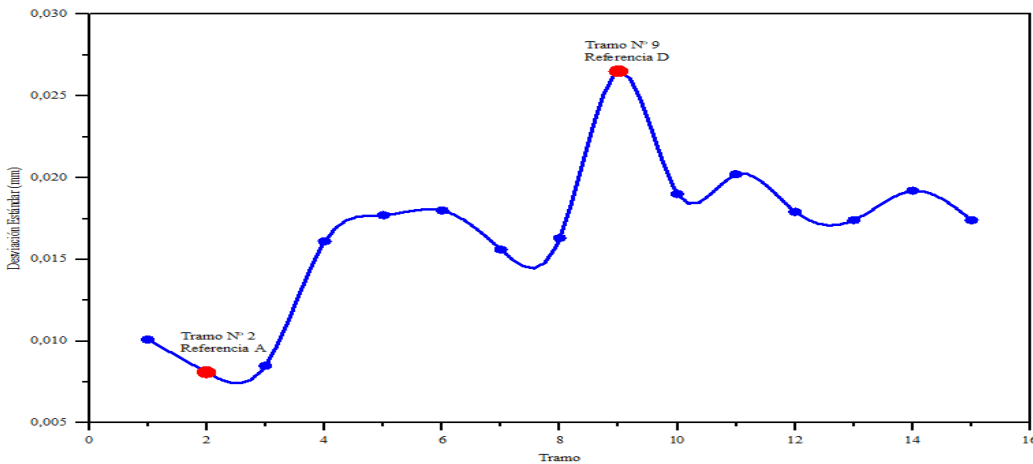
Fig. 11: Trend Curve with the Highest Standard Deviation. Fountain.

On the basis of the data presented in the Board 3 herself points out that reference point D in section 9 has a greater dispersion of data, since the data are heterogeneous due to the gradual loss of surface material at that reference point, in the Fig. 11 herself Look at the dispersion of data by each leg. As can be seen in the Fig. 11, Reference point A of section 2 has a lower dispersion of data, due to the homogeneous data, which is caused by sediments and particles present at the top of the pipe.
