Statistical Analysis of the Technical Condition of the Irrigation Pipeline of the Community of San José De La Silveria through the Measurement of Thicknesses by Ultrasound

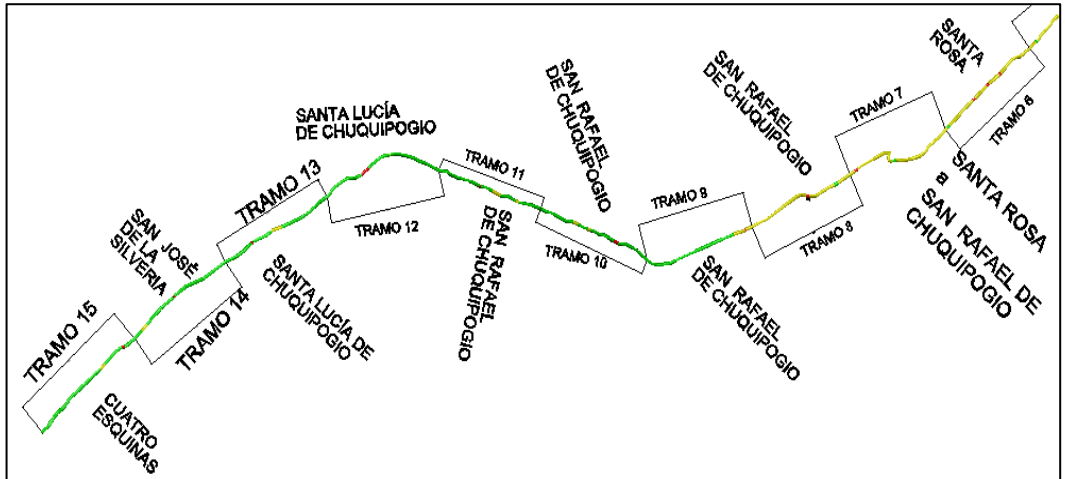
Fig: 2

Based on the nominal thickness value of 7.11 mm, proposed by Quinchuela in 2021, an average wear of 1.66 mm is observed at reference points A, B and D, which represent a minimum wear of 25.4% due to the location of these reference points, as can be seen in Fig. 2 resulting in less fluid alteration and a lower wear rate.
